Tube #45 QE

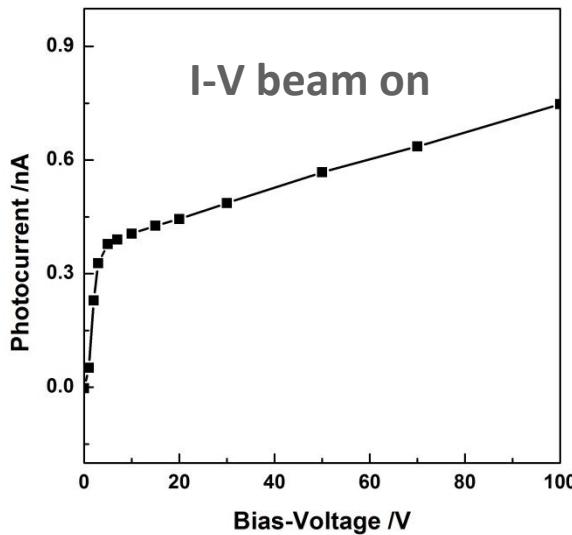
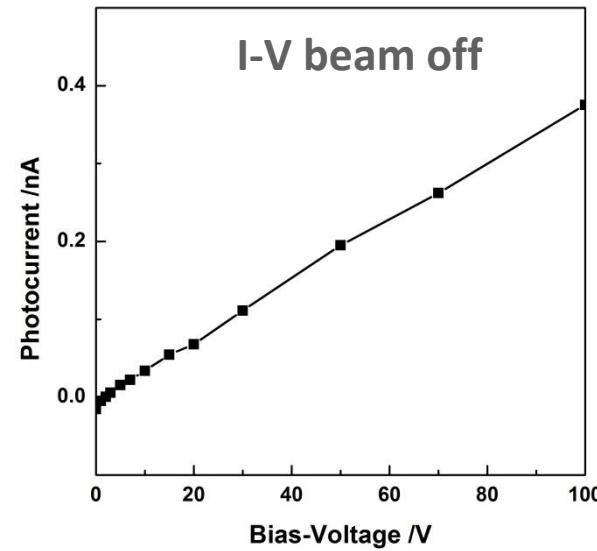
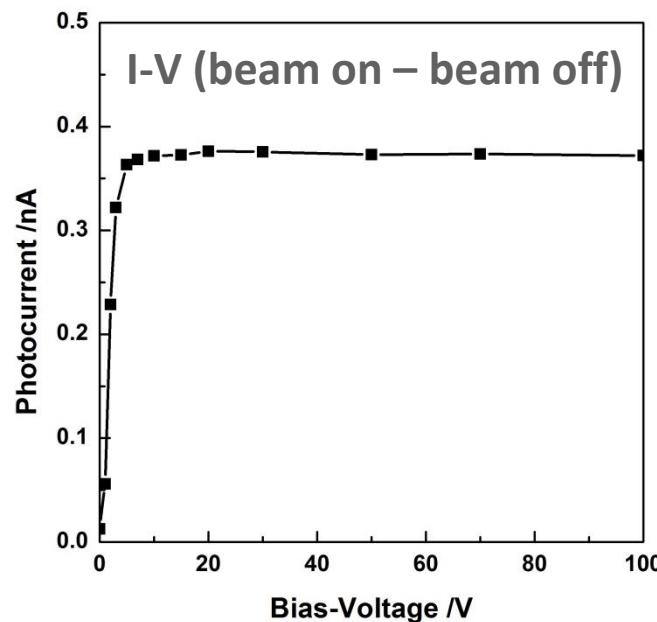
I-V curve

Spacer glass resistance = $2.5 \times 10^{11} \Omega$

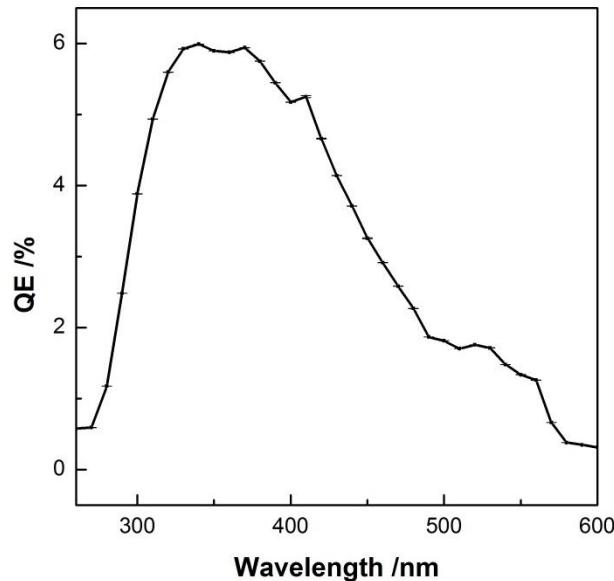
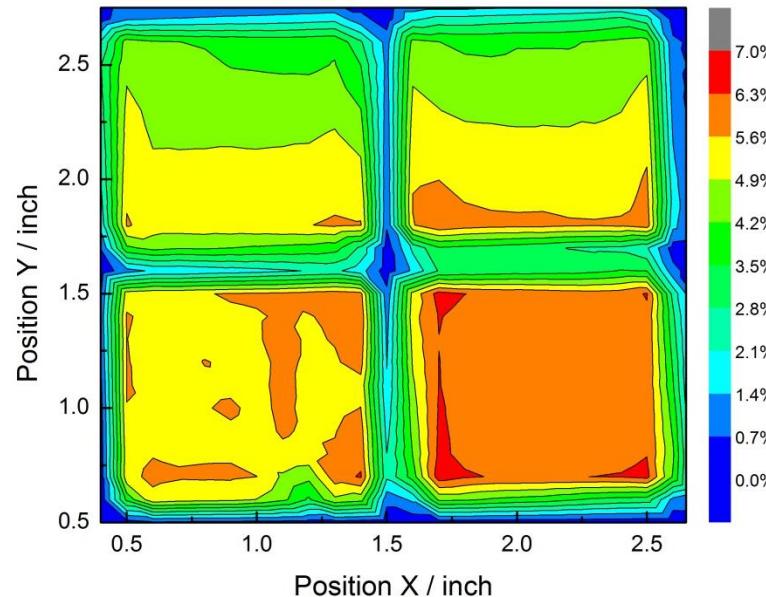
QE vs. wavelength and Map

- No Cs deposition for # 45 as Cs source gives out a large amount of gas during #44 growth, increases pressure to mid 10^{-7} Torr, reducing photocurrent.
- K_3Sb shows maximum QE $\sim 7\%$. Average 5-6 %. Same as #44.

Source may be contaminated during loadlock leakage time (after growth of #43). #41, #42, #43 all show reduction of sealing chamber pressure after cathode was moved to sealing chamber, while #44, #45 did not reduce sealing chamber pressure.

In-situ laser monitor shows final photocurrent of #45 before sealing is two times higher than that of #44. Ex-situ measurement shows same QE.

Cathode #44 also has NO Cs deposition?? Both #44 and #45 are K-Sb only cathode, No Cs?

Cs directly reacts with the contamination gas, did not reach to substrate. The K-Sb #44 cathode recovers itself after sealing??
